POPPLETON HISTORIC STUDY

B-2758

<u>Block</u>	<u>Lot</u>	<u>Address</u>
253	18-27	125-141 S. Poppleton Street

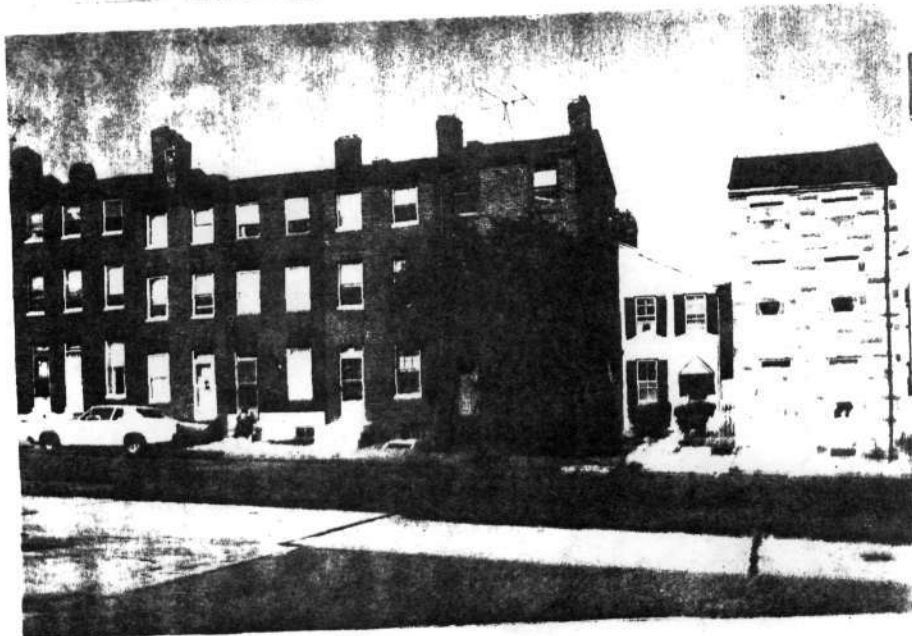
As soon as one turns the corner from Pratt into Poppleton, the houses are better, though by no means well kept. This is an interesting terrace with variety of roof line, generally following the rising contours as it steps up the hill. They should be rehabilitated before they slip into further disrepair. There are no dramatic details but some ironwork. The two set back houses are worth noting as old or in an early shed roof vernacular and quite charming. Number 137 is very well kept. It is half of a gable house, the rest being behind number 135 (as was the case at 888-888½ W. Lombard Street). Original ironwork remains at 123; 139 is formstoned.

Environmental context: Lot at 141 (on corner of Pratt) is vacant, but no vacancies in this entire block face. The empty corner lot has a large billboard which should not be; a mini-park, trees and a bench would be more appropriate (as is in process at HCD). There is one nice old Linden tree but it needs company. The entire corner of the block opposite has been cleared; the park-use planned by HCD for this corner seems appropriate.
